# Sprocket Alignment

## Practice for Aligning Sprockets

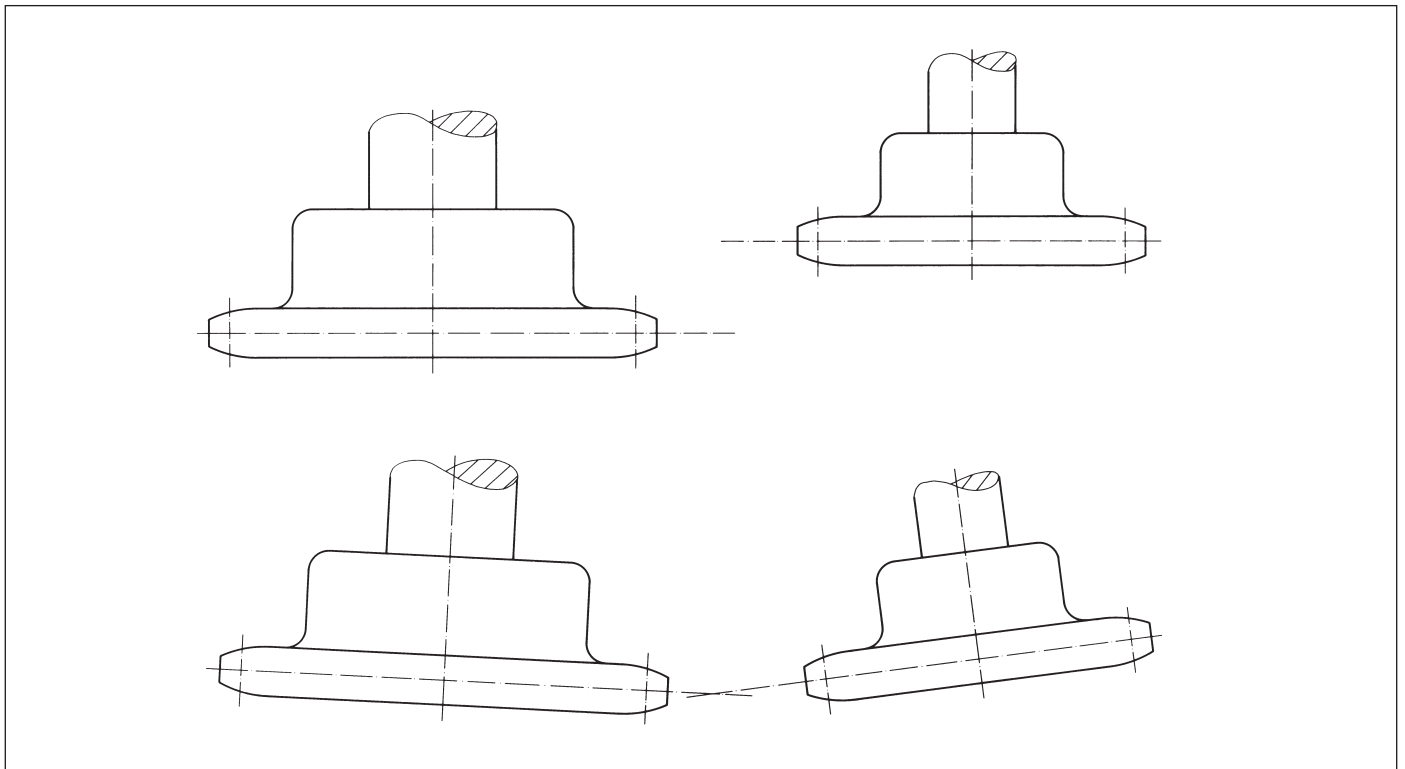
## Examples of misalignment

Where the misalignment exceeds the specified value or if there is no support in the case of vertical chain drives, the following can be observed.

- The inner links of the chain will interfere with the sprocket teeth resulting in continuous knocking of the inner link plates, which are eventually pushed outwards until they contact the outer link plates and reduce the freedom of movement.
- Vibration will also be observed which will further accelerate the wear of both chain and sprockets.

- Sprockets should be replaced and aligned whenever new chains are installed. This will have a significant effect on chain life.
- Particular care should be paid to ensure that the shafts are installed parallel and that sprockets are aligned. Both can be accomplished quickly with a laser alignment tool.
- Maximum misalignment for slow moving application (under 10 ft/sec) is 0.2% of the center distance. For faster moving running drives, misalignment should not exceed 0.1% of the center distance.
